2025

SEASON REPORT

CCF TRAIL STEWARDSHIP PROGRAM

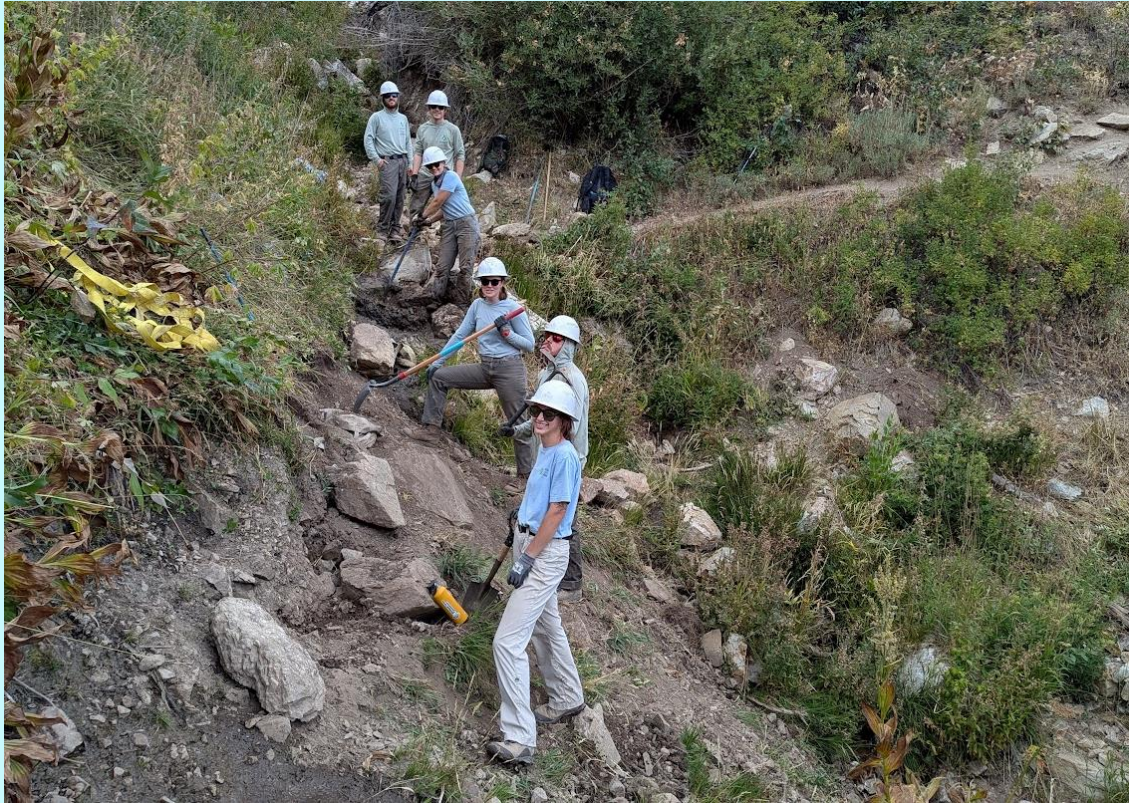
The CCF Trail Crew building drainage structures on the Deseret Peak Trail. Photo credit: Emily Salle.

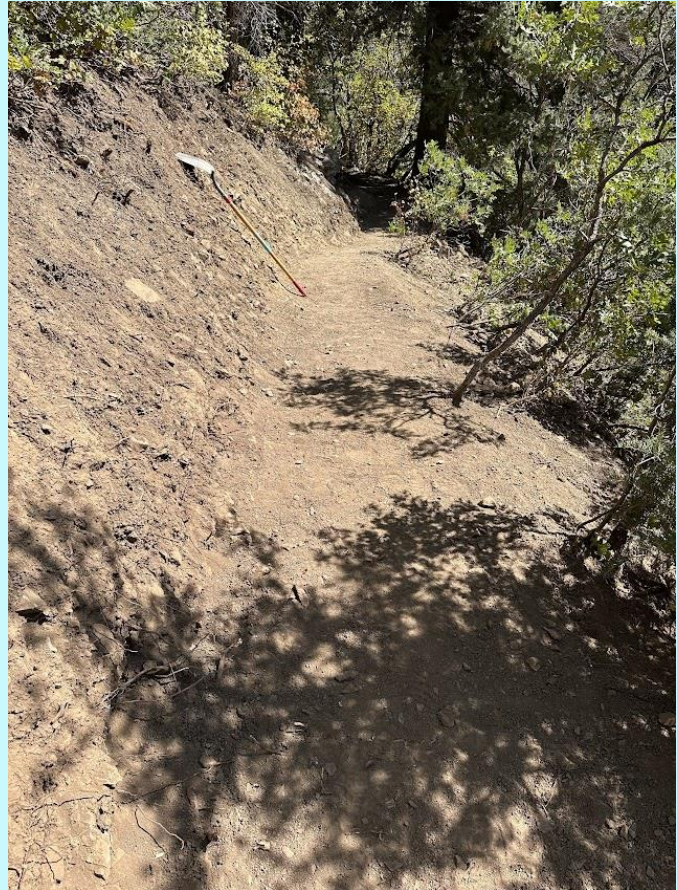
A completed section of the Pipeline-Elbow Fork Connector. Photo credit: Jillian Sands

CCF created a new trail connecting the Pipeline Trail to what will be the new Elbow Fork Trailhead parking lot in Millcreek Canyon. Combating thick vegetation and a sidehill grade of as much as 60%, the crew produced 337 ft of new trail with a 3ft bench. Several sections required reinforcement with retaining walls as a result of the rugged terrain.

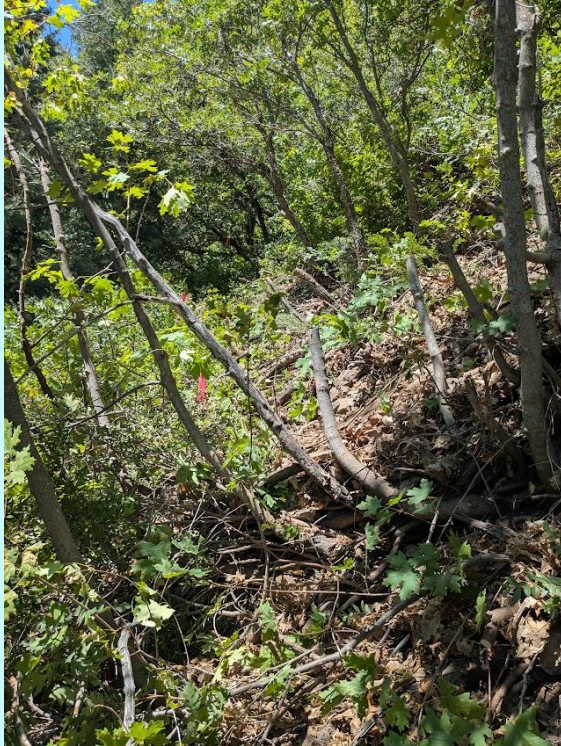
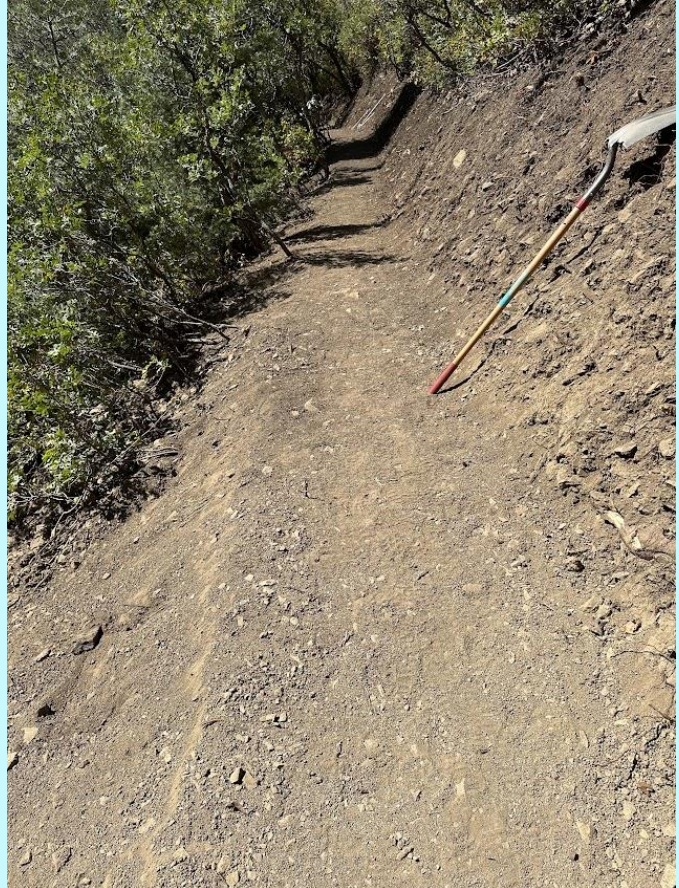
Before (above left) and after (right) of the site. Below, a reinforced switchback. Photo credit: Emily Salle, Jillian Sands

337 ft new tread

319 ft³ retaining wall

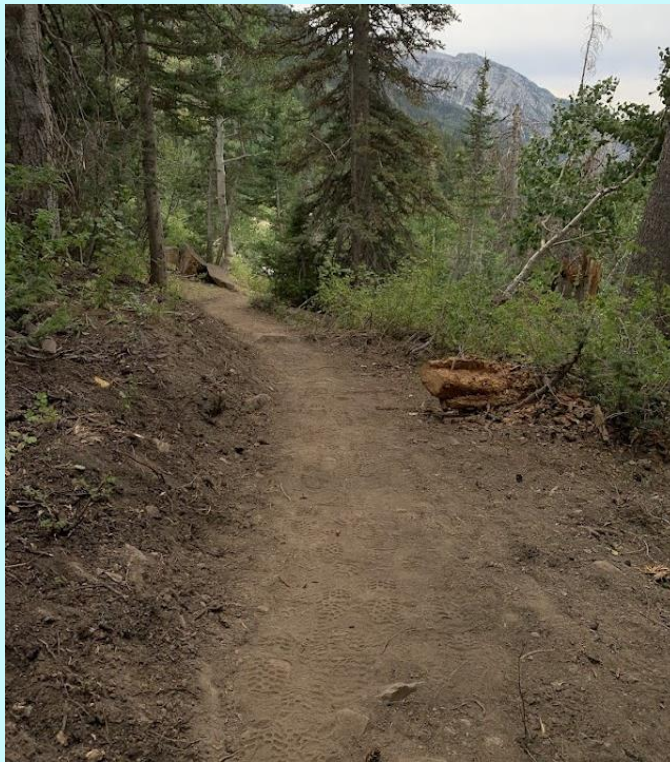
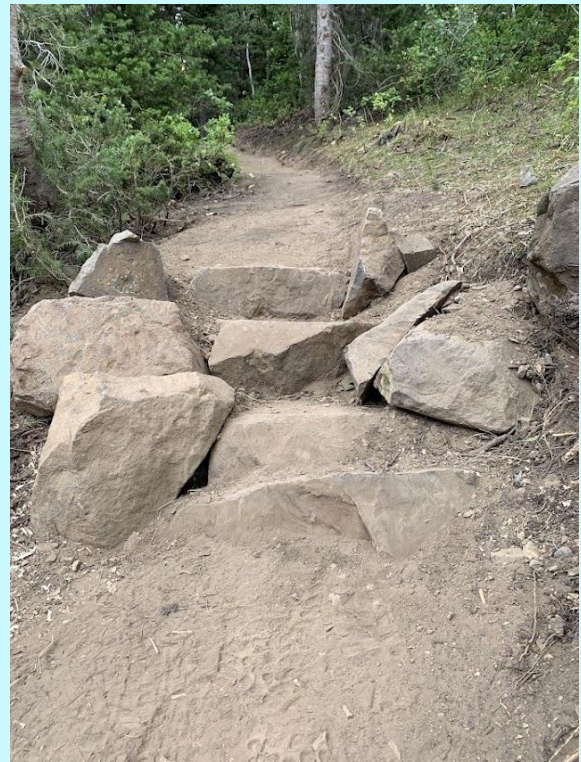
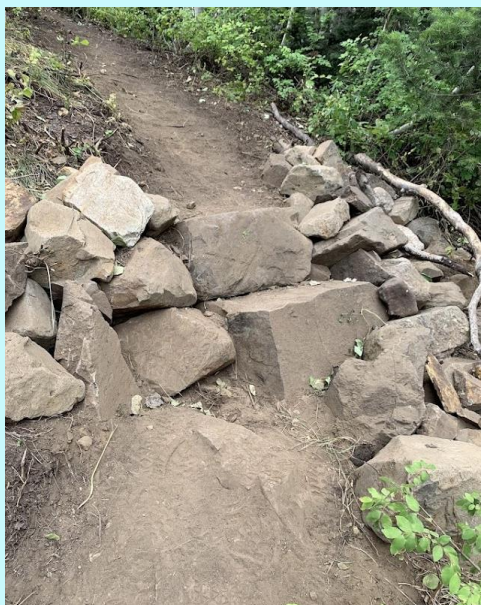
Examples of finished structures and sections.
Photo credits: Grace Goodwin-Boyd

This reroute circumvented a washed-out section of trail and replaced it with a sustainable option. The new section of trail features switchbacks and gentler grades that facilitate water shedding and provide a more pleasant user experience.

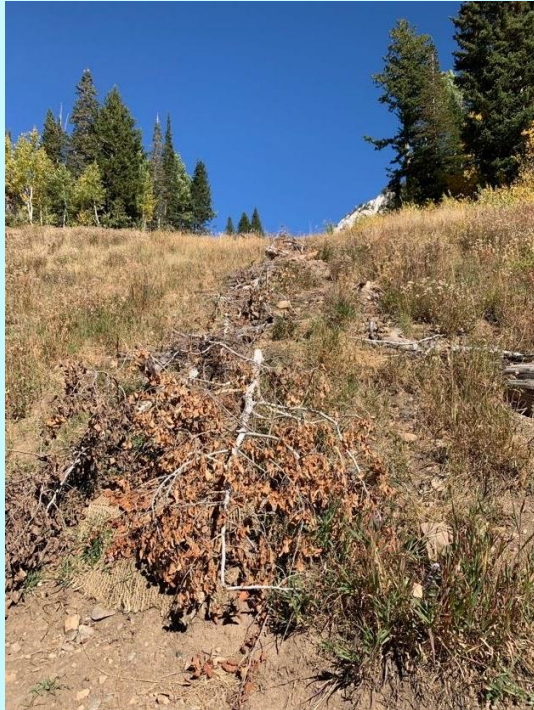
The old section of trail was restored with restoration checks, native plants, and debris. Photo credits: Grace Goodwin-Boyd

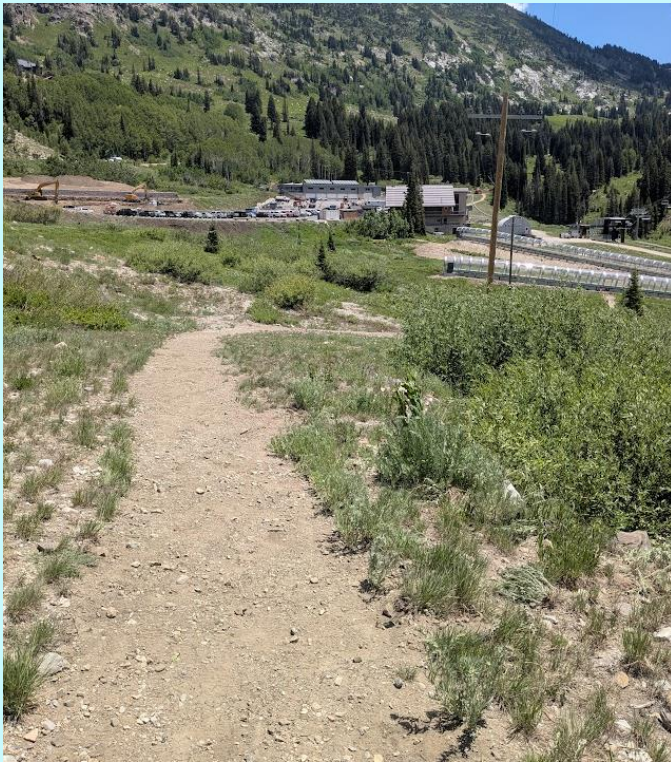
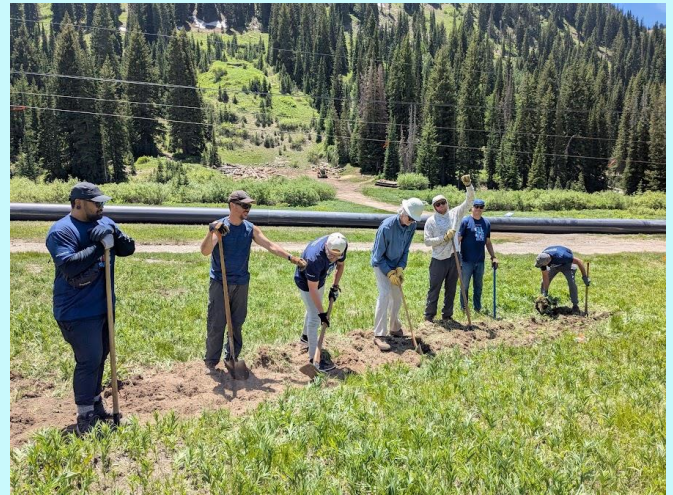
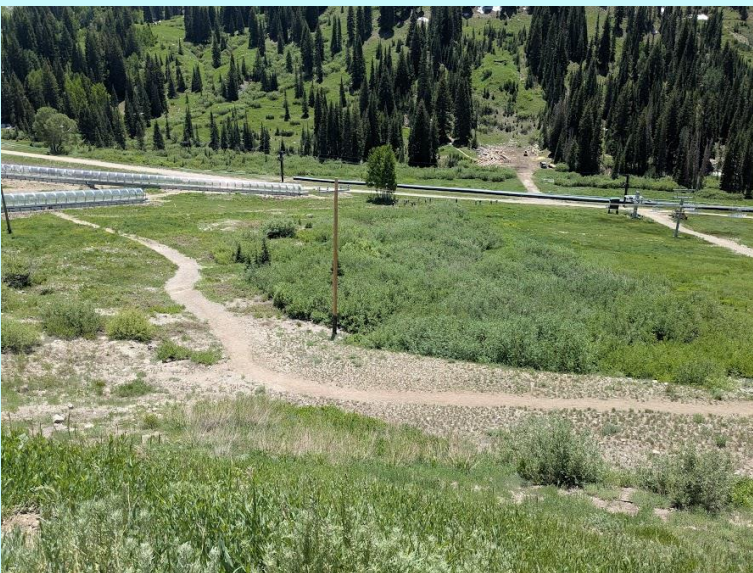
Finished sections of trail (top and bottom left) and crew and volunteers working on a section of trail (top right). Photo credit: Emily Salle

Thanks to an incredible effort from the CCF Trail Crew and volunteers, the Lower Albion Meadows Trail reroute at Alta was completed in just a day and a half. The new section of trail measures **477ft**. It avoids newly installed ski infrastructure and is a well-graded addition to the existing trail.

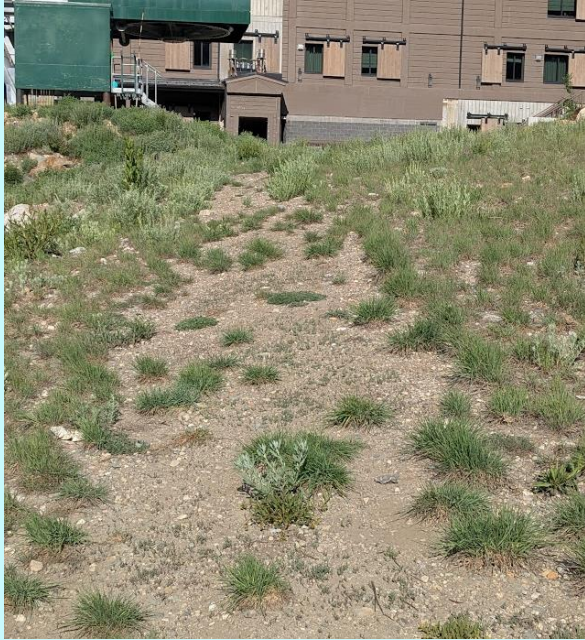
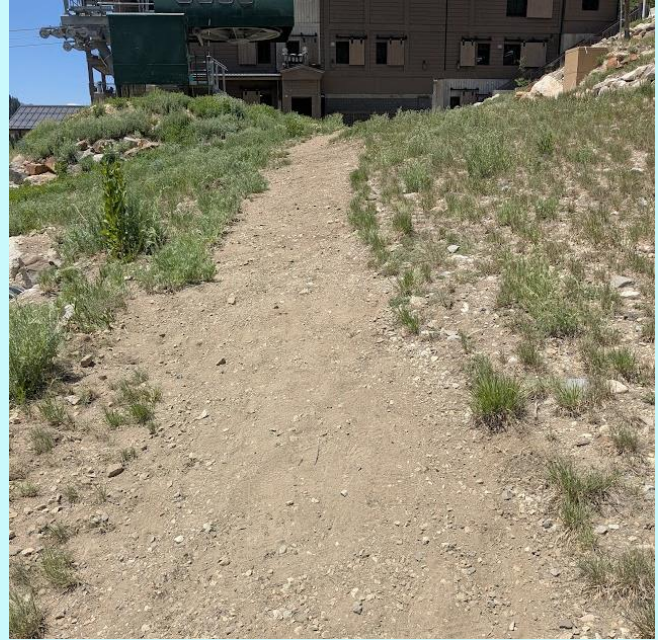
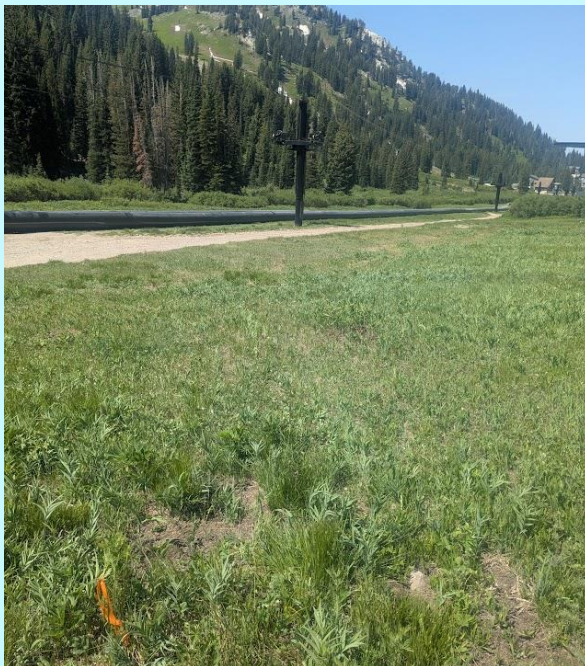
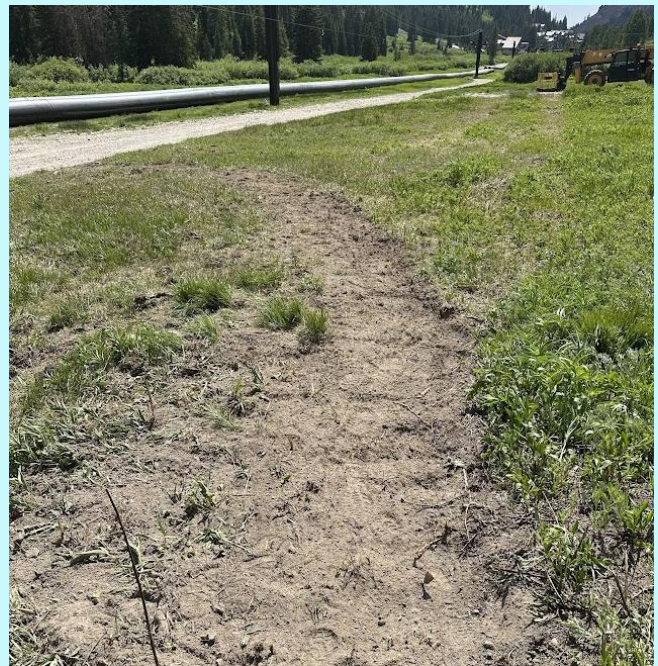
Lower Albion Meadows Trail Reroute: Before and after

Before (left side) and after (right side). Photo credit: Emily Salle

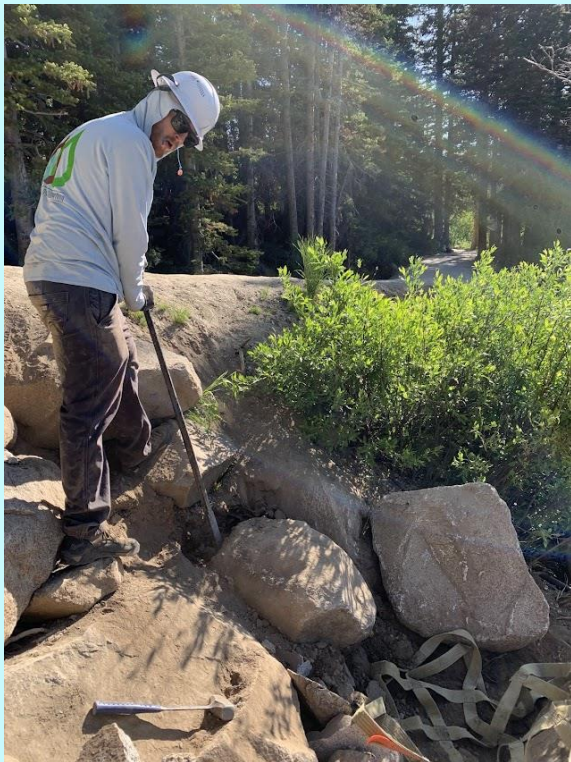
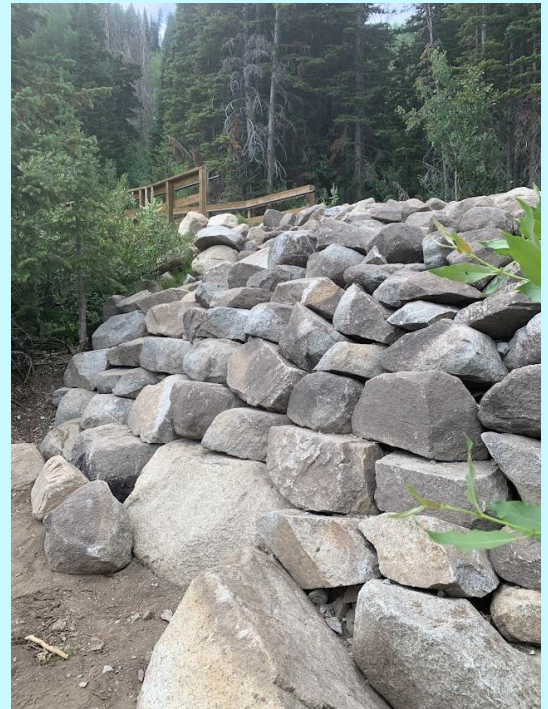
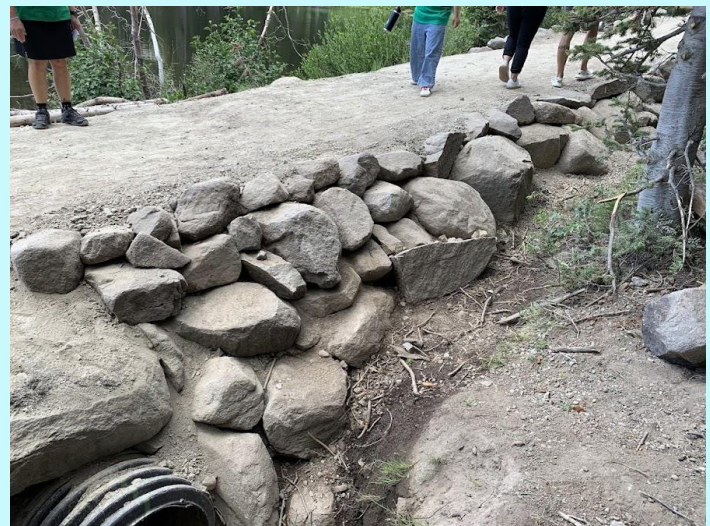
The CCF Trail Crew built a large retaining wall adjacent to the Silver Lake boardwalk to support a section of trail and to stabilize large rocks in that area. The project also included bolstering a two-tier retaining wall on the opposite side of the trail to prevent erosion of that section, as well as naturalizing an area that was crossed with social trails.

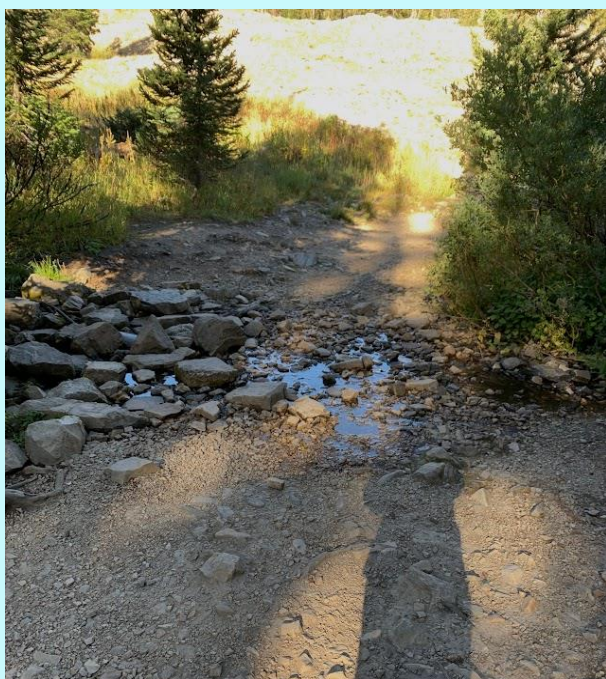
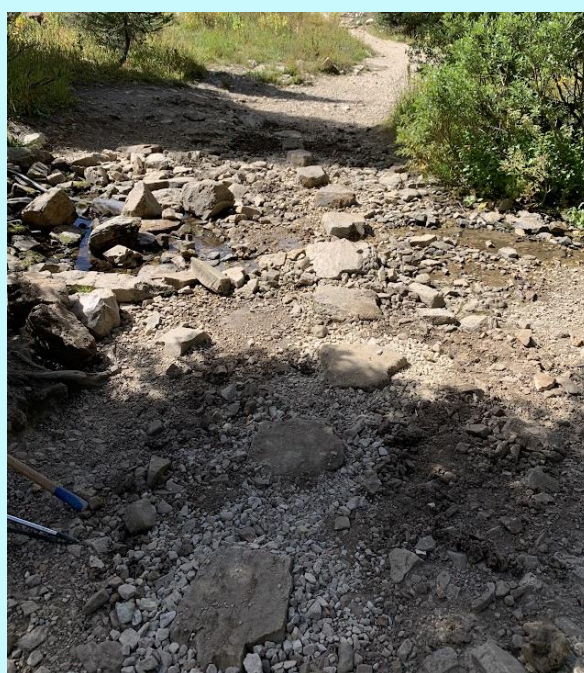
Before and after of a stream crossing on the Cecret Lake Trail. Photo credit: Grace Goodwin-Boyd

The Cecret Lake Trail at Alta is well-loved and sees high traffic throughout the summer. The CCF Trail Crew built two sets of stepping stones on the trail to minimize impact on the watershed at stream crossings, and restored social trails that had formed due to users trying to avoid the water.

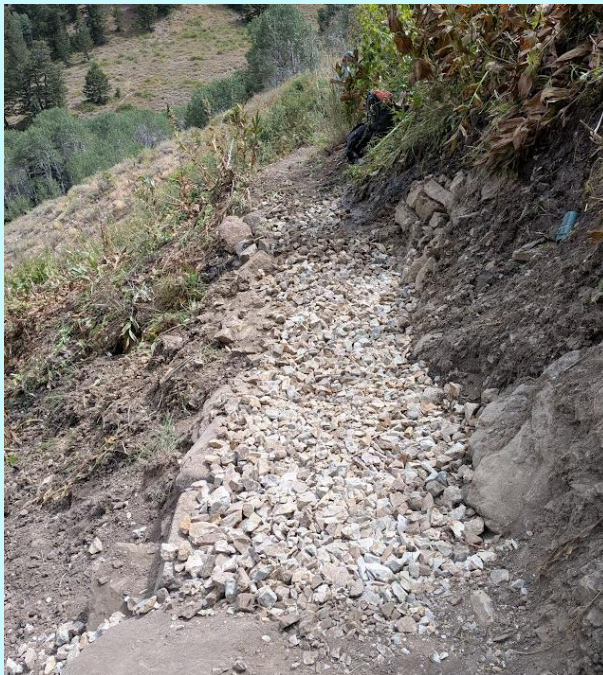
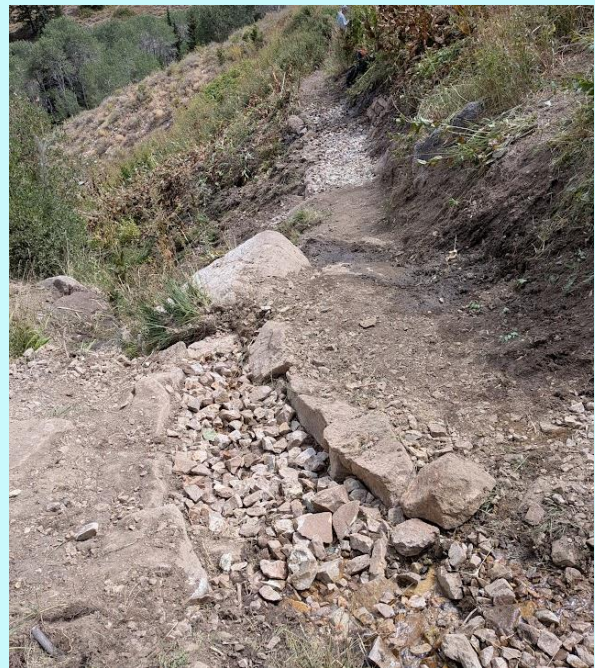
French drain, left, and open culvert on the Dry Lake-Pockets Fork Trail. Photo credit: Grace Goodwin-Boyd

The Dry Lake-Pocket's Fork Trail project provided an opportunity for the crew to get out of the Cottonwood Canyons and mix it up with a work week in the Stansburys. They camped at the South Willow Lake Guard Station to make this excursion possible. The focus of the week was on a muddy, eroded section of trail where the crew installed a French drain, a water bar, and a reinforced stream crossing. The result was a wider, drier, more navigable section of trail.

1 French drain (51 ft³ rock)

1 open culvert (14 ft³ rock)

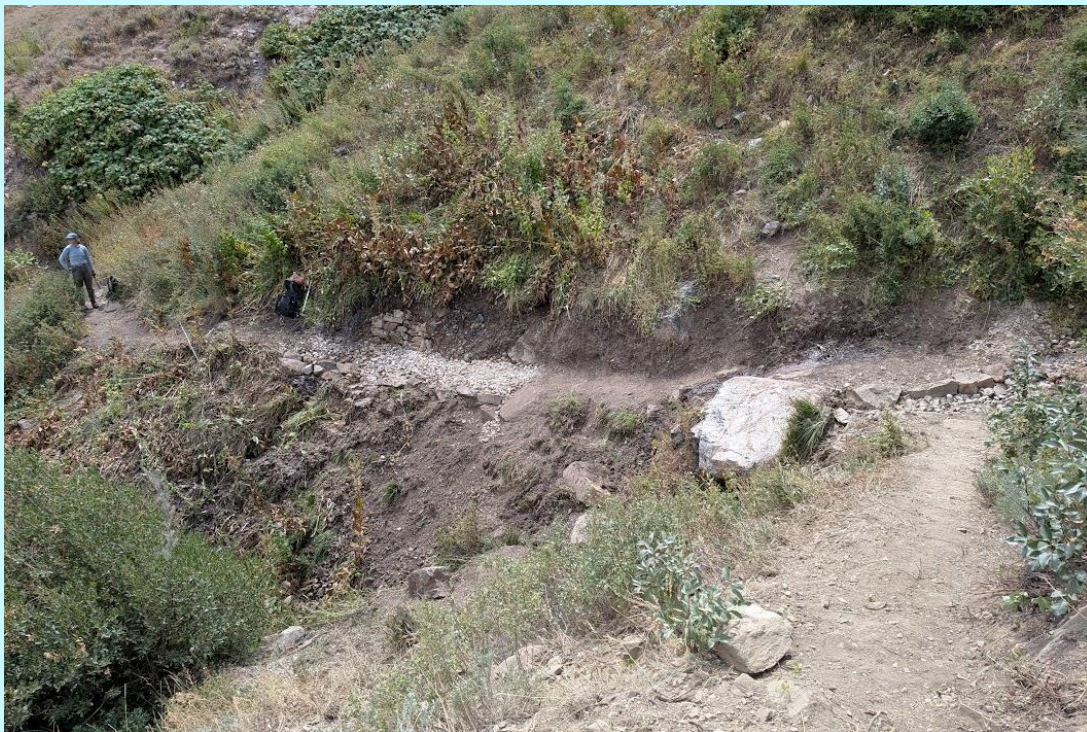
Wide view of the project site on the Dry Lake-Pockets Fork Trail. Photo credit: Emily Salle

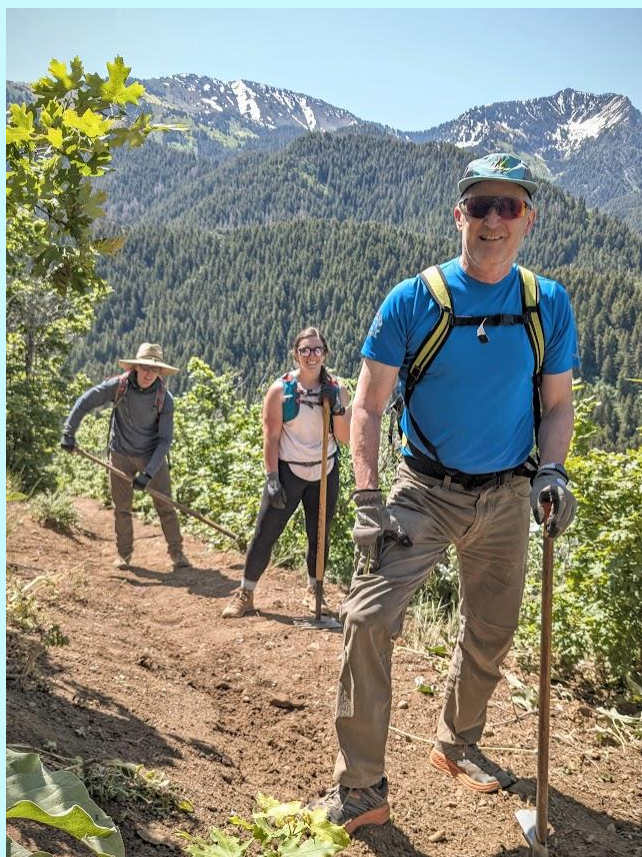
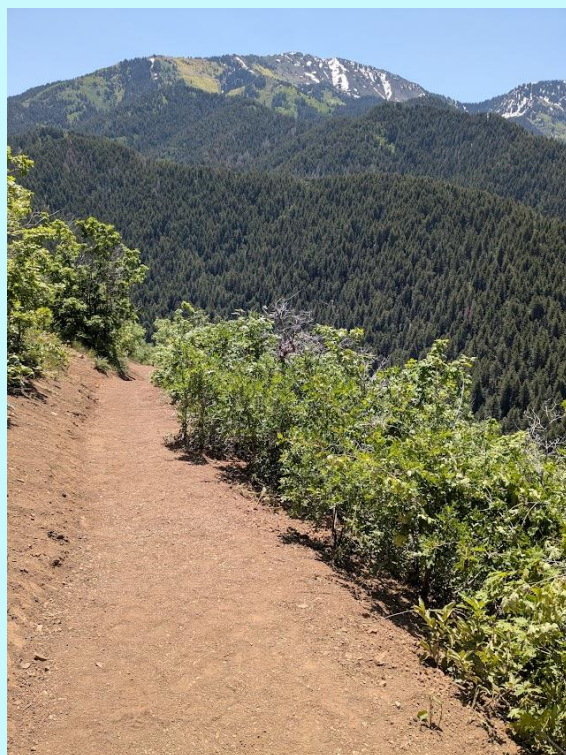
The Burch Hollow trail had not been maintained in 25 years and had just about disappeared. With help from volunteers, the CCF Trail Crew cleared the corridor on the entire trail and restored a majority of the tread, bringing it back to about two feet in width and realigning eroded sections.

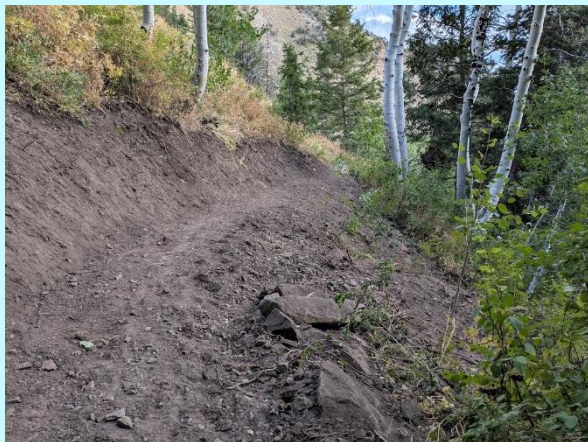
Restored tread on the Dry Lake-Pockets Fork Trail.
Photo credit: Emily Salle

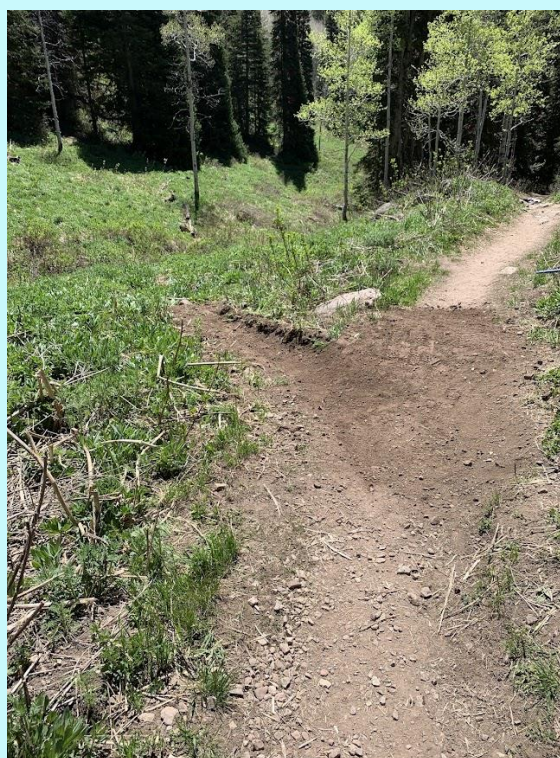
A cleared drain on the Lake Desolation Trail.
Photo credit: Grace Goodwin-Boyd

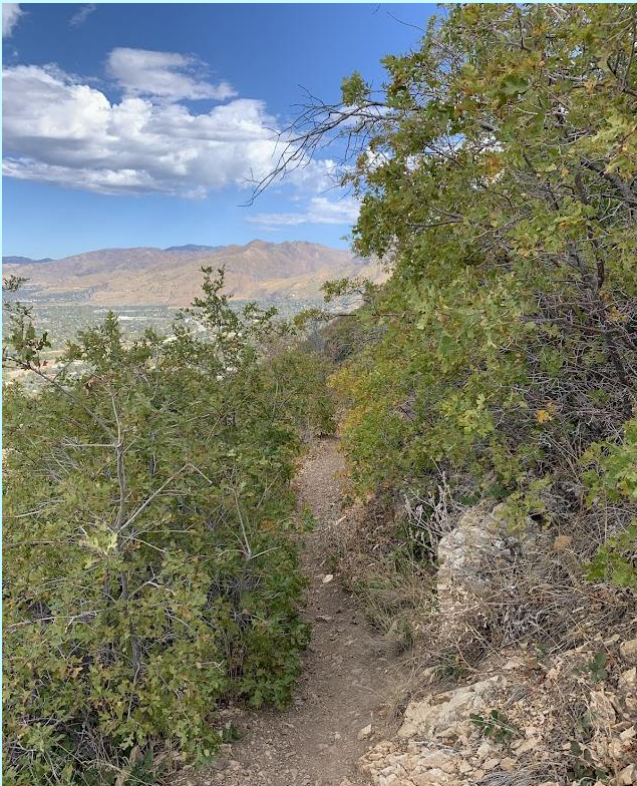
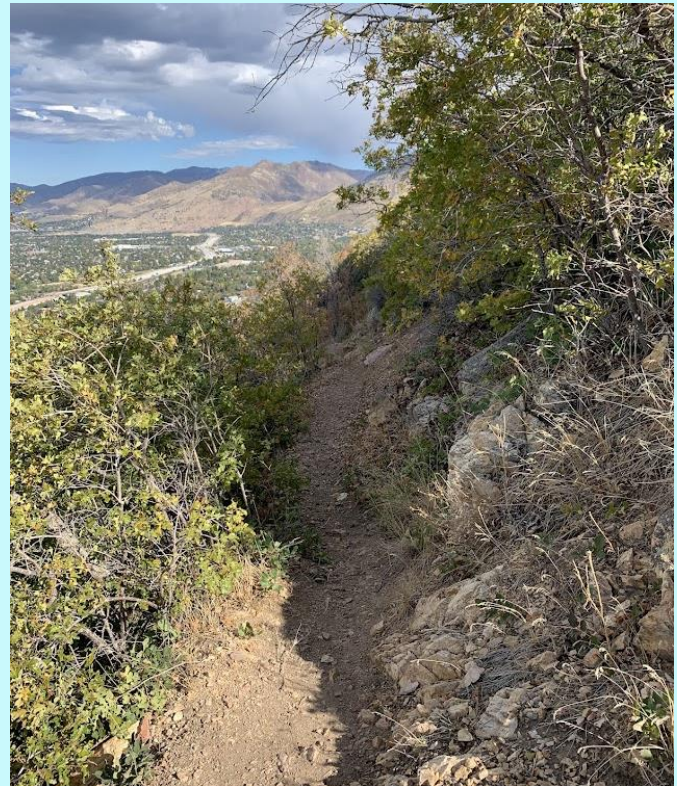
Before and after photos of corridor maintenance on the BST. Photo credit: Grace Goodwin-Boyd
